BILJANA BOBIĆ, BORE JEGDIĆ,  
BOJAN GLIGORIJEVIĆ

Scientific paper  
UDC:620.193.4/5

## Analysis of corrosion damage in a boiler made of AISI 304L stainless steel

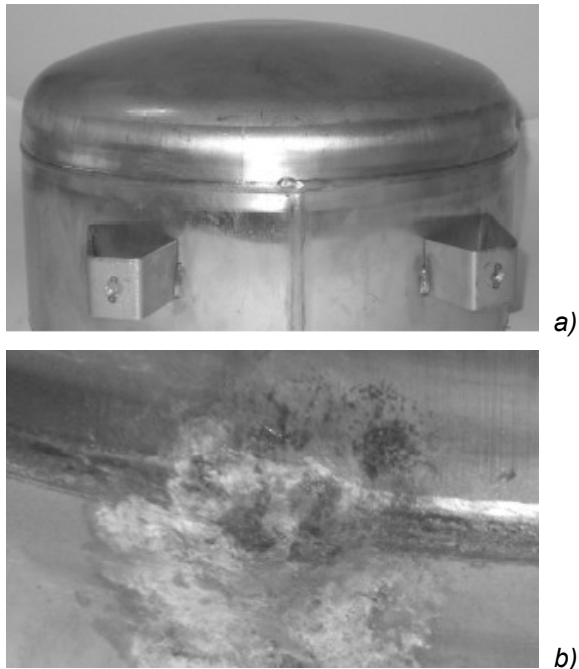
The outer side of the boiler with longitudinal and circumferential weld is shown in Fig. 1a. The welding was performed in the shielding gas (formier gas). The position of the boiler perforation is presented in Fig. 1b. The leakage of the water in this place was significant.

Figure 1 - General appearance of the outer side of the boiler: a) welded joints, b) corrosion damage near the welded joint

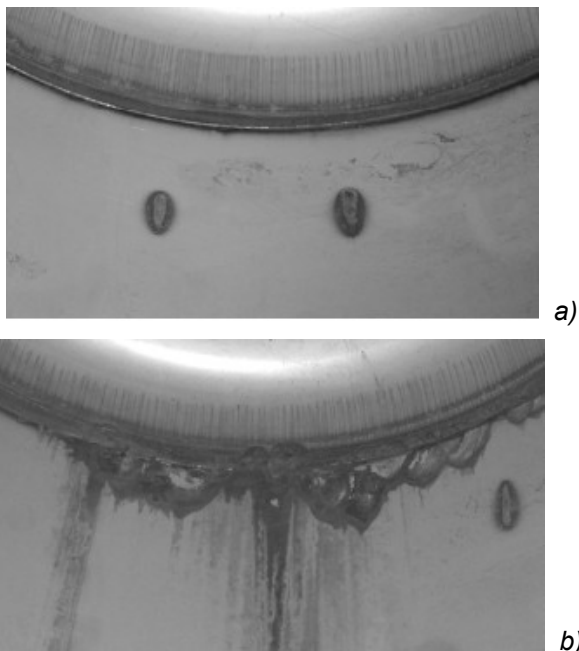
The appearance of the inner side of the boiler with the circumferential welded joint is shown in Fig. 2a and 2b. The welding was performed without the shielding gas. The presence of the crevice near the heat tint can be seen. The two oval heat tinted surfaces near the circumferential welded joint are shown (Fig. 2a). All heat tinted surfaces were corroded. Intensive corrosion processes in the

crevices resulted in the perforation of the boiler during exploitation (Fig. 2b and 3).

Figure 2 - General appearance of the inner surface of the boiler, a) heat tinted zones, b) corrosion damages near the welded joint

Heat tint in the root of circumferential welded joint on the inner side of boiler was formed because the welding was performed without the shielding gas. Heat tint on the outer side of boiler was not formed because the shielding gas was used during welding. The longitudinal welded joint was also formed in the shielding gas (root and the face side of the weld) and the heat tint was not formed.

Corrosion processes occurred in the circumferential welded joint and oval heat tinted surfaces near the circumferential welded joint, because of heat tint formation in the inner side of the boiler. On the oval heat tinted surfaces general corrosion occurred with uniform thinning of the metal. The appearance of the local forms of corrosion was not noticed.

During designing of the boiler the crevice was formed in the region of the circumferential welded joint (Figs. 2 and 3). In the presence of the crevice and the heat tint in this region the stainless steel AISI 304L corroded during exploitation. The formation and propagation of pits inside the crevice resulted in perforation of the boiler wall near the circumferential welded joint.

Designing of the boiler without crevices.

Welding should be performed in the shielding gas to prevent formation of the heat tinted zones.

If formed, heat tint should be removed according to the standard ASTM A380.

Replacement of the stainless steel AISI 304L with the stainless steel AISI 316/316L which contains 2-3 % Mo, because this stainless steel is far more resistant to pitting and crevice corrosion.

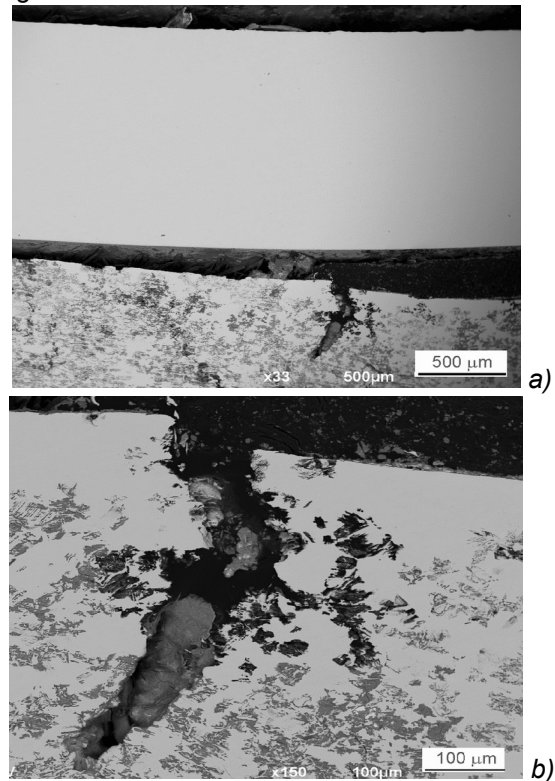
Figure 3 - SEM microphotographs of the corroded surface with a) crevice and b) pitting

The corrosion damage in the boiler of AISI 304L stainless steel was analysed. It was shown that heat tint was formed near the circumferential weld joint on the inner side of the boiler. Corrosion resistance of the heat tinted zone is lower compared to the base metal. Due to the presence of heat tint and crevice in the welded joint, pitting corrosion occurred which caused the perforation and leakage of the boiler.

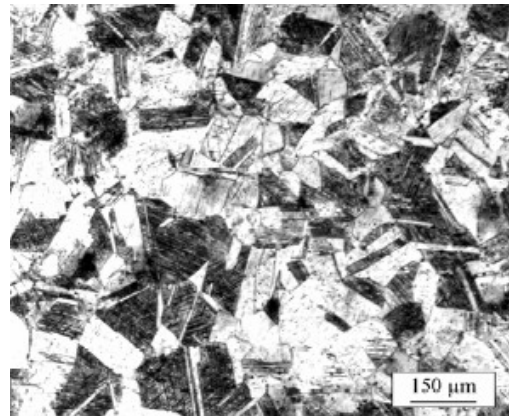
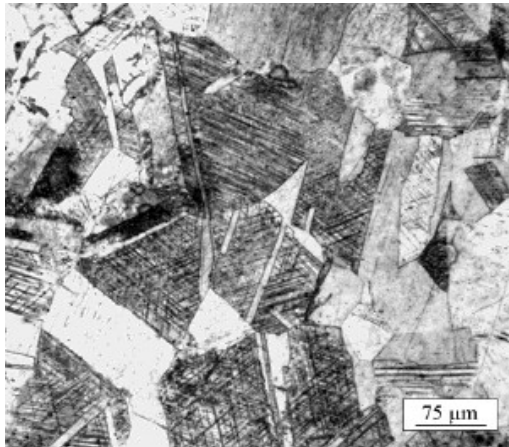
Figure 4 - Microstructure of the base metal (OM). Etched in aqua regia.

shown to be 6, according to ISO 643: 2003, at magnification x100.

Microstructural examination of the base metal has revealed that the microstructure is austenitic, with twins of austenite (Fig. 4a and b). The microstructure is regular, without imperfections (inclusions and impurities). Grain size index was
