## Corrosion inspection and protection of diesel storage tank

The standard corrosion inspection of the process equipment in the OKTA Crude Oil Refinery in Skopje include control of all pressure vessels and storage tanks in the refinery. As a part of the standard inspection activities, an inspection of storage diesel tank was done. The inspection consists of visual control and ultrasonic thickness measurements during the course of time. The obtained thickness values on predetermined locations were than compared to the required standard values.

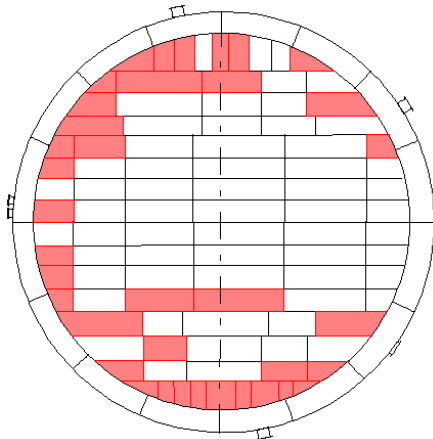
The inspection showed that 37 sheets have lower thickness than the allowed, which is 33% from the total number of steel sheets. On Figure 3 a schematic presentation of the tank bottom is given, with the corroded sections highlighted.

Figure 3 - Scheme of the locations on the tank bottom with expressed corrosion and lower than allowed thickness

As can be seen on Figure 3, the corrosion is located mostly on the lower tank bottom section, next to the annular ring. Some of the characteristic corrosion types are presented in the following section: appearance of corrosion (Figure 4), thickness reduction of the tank bottom caused by corrosion (Figure 5), appearance of pitting corrosion on the tank bottom annular

The inspection activities done pointed to the most critical sections of the tank in terms of corrosion. The corrosion is most expressed on the tank bottom, less on the roof and it is rarest on the tank shell. The corroded steel sheets with thicknesses lower than the standard allowed were replaced with new.

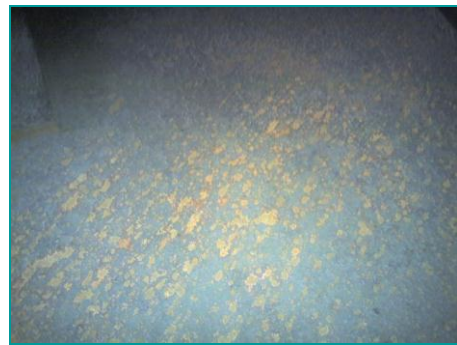
Figure 4 - Tank bottom section with visible appearance of corrosion

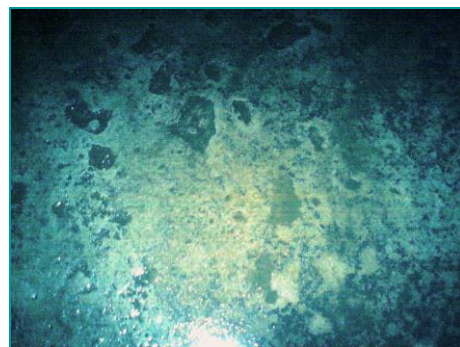
Figure 5 - Appearance of tank bottom section with visible thickness reduction due to corrosion

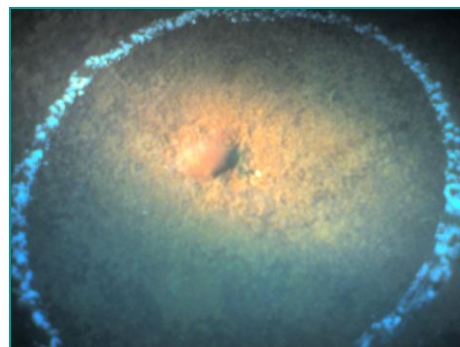
ring, with reduced thickness of 1,4 mm (Figure 6) and corrosion on the central section of the tank bottom, near the welded joint of two sheets (Figure 7).

Figure 6 - Appearance of pitting corrosion on the tank bottom annular ring

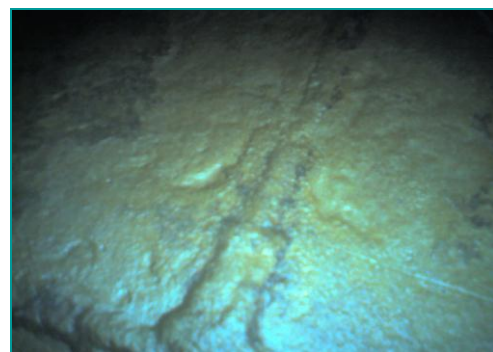
Figure 7 - Corrosion on the welded joint of two steel sheets

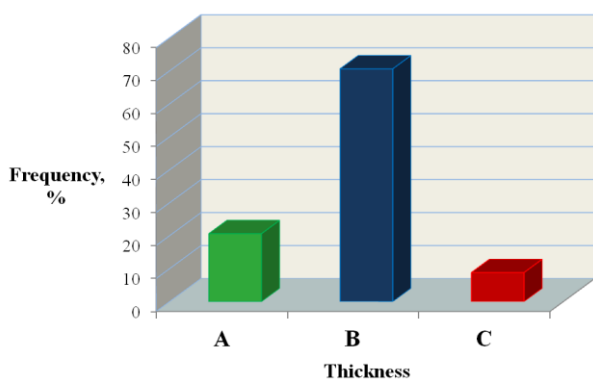
Figure 8 - Values of measured thicknesses on the central tank bottom section

The taken measurements show that the most expressed corrosion is present on the tank bottom: from total of 232 measurements done on the steel sheets, on 186 a thickness reduction due to corrosion was found, which is over 72% (Fig.8). From them, it was necessary to replace 21 sheets, which represents 9,65%. It was noted that the corrosion is most expressed on the peripheral sheets, as well as on the

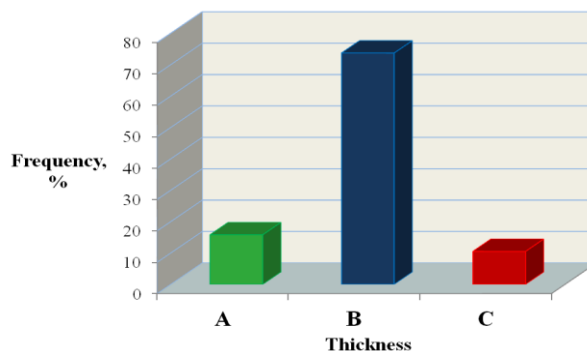
sheets of the annular ring (Fig.9). This is due to the design of the tank bottom itself, which has a high point in the middle and low points on the ends, which enables collecting and retaining of water.

Figure 9 - Values of measured thicknesses on the tank bottom annular ring

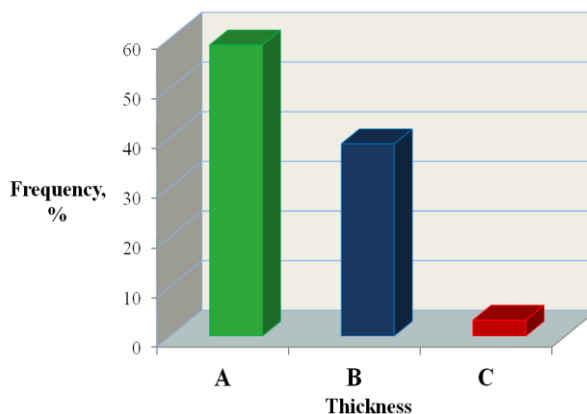
Figure 10 - Values of measured thicknesses on the tank shell

The shell of the tank showed the smallest thickness reduction – on 58,6% the thickness remained unchanged, on 38,7% a small thickness reduction was recorded, and only on one location the thickness reduced from the design 12 mm for 0,8 mm (Figure 11).

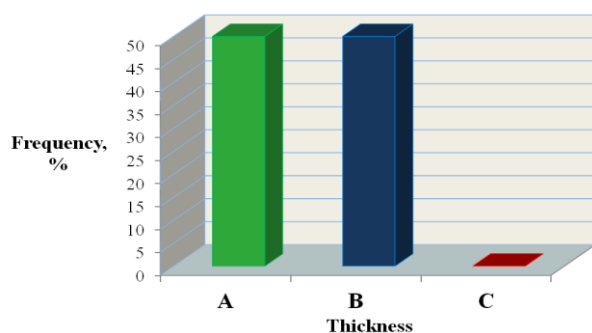
The fixed roof of the tank is in relatively good condition. The thickness remained unchanged on 50% of the measured locations, while on the others the thickness was slightly reduced – from the design 4 mm, the thickness was reduced from 0,1 to 0,3 mm (Fig.10).

Figure 11 - Values of measured thicknesses on the tank fixed roof
