Scientific paper

Zastita Materijala 63 (4)

Choosing the procedure for repair of damaged arm at an unicate desk lamp

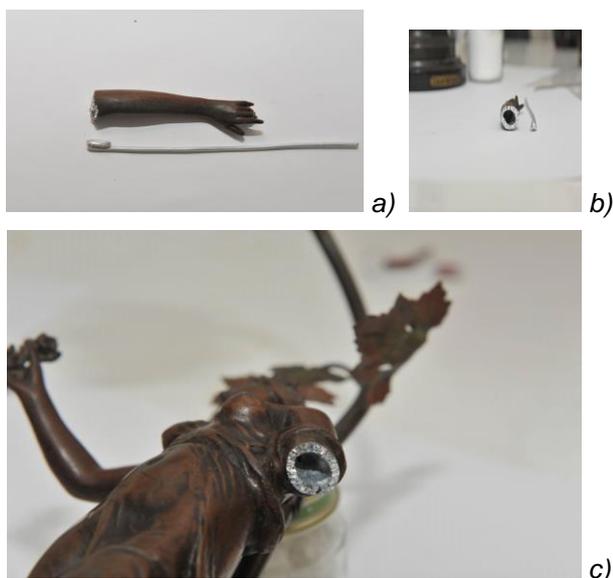
The lamp is damaged at the left side of statue, exactly on the arm near elbow but just over this place, see Fig. 2a). At this place the arm from the lamp was hollow, Fig. 2b).

Figure 2. Broken arm in two views a) and b); look at the lamp from downside c)

The inner diameter of hollow at broken arm was about 10mm, with wall thickness about 2mm. The depth of this hollow part was about 45mm. At the broken wall could be seen the great dendritic grains which is characteristic for as-cast structure of used alloy, see figs. 2b) and c). The hollow arm indicates that the lamp body is produced from various components which are first casted and then connected either by welding or brazing.

At damaged surfaces were not registered any defects originated from a casting period, as like shrinkage, slag or non-metallic inclusions, which generally may appear in as-cast structure, no matter what kind of alloy is used. Generally, as-cast structure is a brittle.

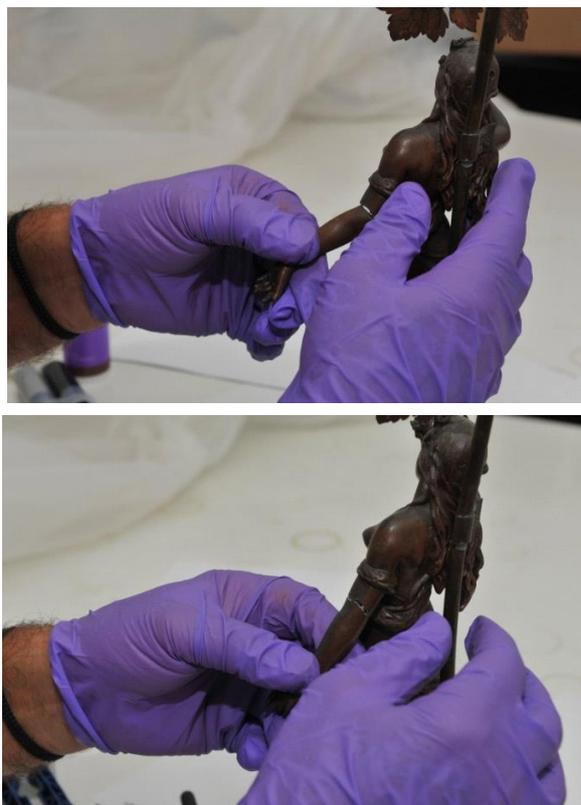
Figure 3. Two views of preliminary assembling of damaged arm to lamp body

The preliminary assembling of damaged arm to the body lamp is shown in Fig. 3. This assembling has confirmed that there is no missing material, what represents a favorable condition in this case. If in contrast, the some piece of material is missing on assembling surfaces that the using of some filler metal will be obvious. But, the choosing and than using of a proper filler metal similar to the parent metal of body lamp, and further its surface regeneration to the original appearance of this unicate piece, will be pretty complex job. It is clear that the achieving the same color of filler metal hardly will be find, may be the whole lamp should be copper plated and lacquered.

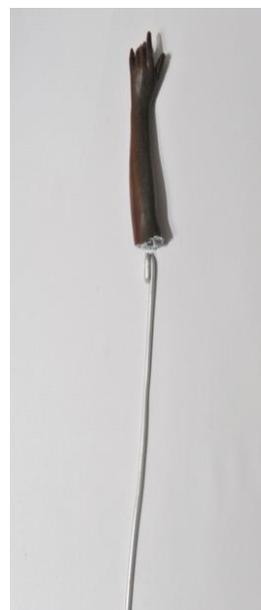
a)

As the third possible way of repairing is considered on reinforcing of glue by inserting an aluminum wire, according to Fig. 4a). It is well known that the aluminum is an inert material in regard to parent material, it is an alloy made of zinc and aluminum, and from that point of view there is no dangerous for corrosion appearance between those materials. But, the limiting factor in this solution is the uncertaintyof such "construction", because it was impossible to fasten the aluminum wire to the lamp body, and then the

Figure 4. Preparing for reinforcing with aluminum wire

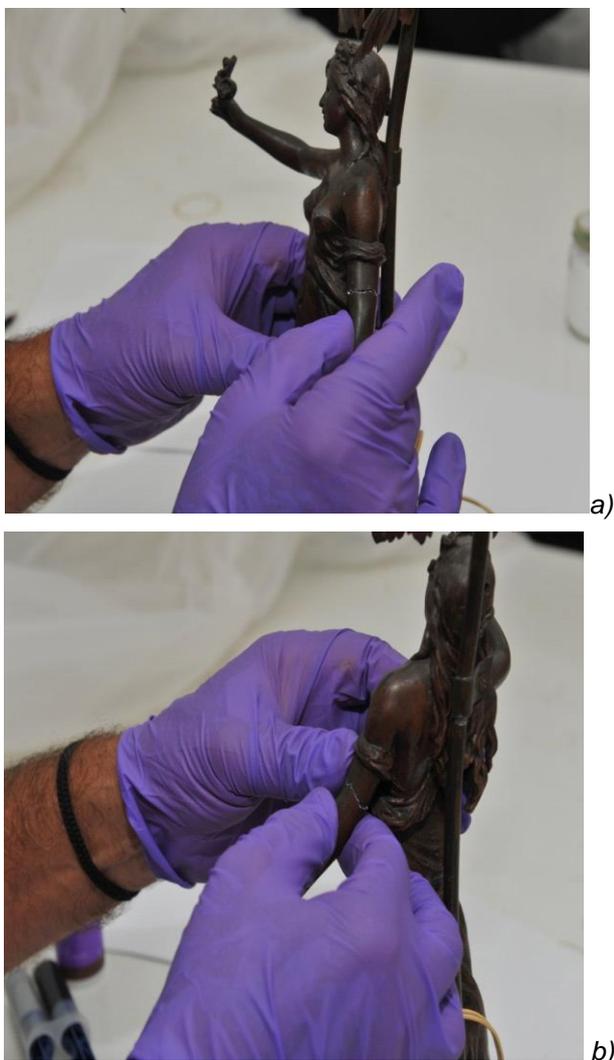
Figure 5. Keeping two components for 6 minutes after all previous works done

The top of the chosen screw is twisted into the small pore, while the head of screw was in position to hang into the hollow of damaged arm. As the screw is made of steel, than the strength of such joint will be satisfied anyway, and at the same time the zinc plated surface is a properly against the parent material, for avoiding a kind of corrosion process. Anticorrosive behavior of coating here means the avoiding so called the contact corrosion of two materials: lamp body from zinc alloy and the zinc plated screw. This way of repairing does not need an application of great amount of glue, so the risk from eventually deformations of relatively thin walls at the arm is really decreased, even eliminated.

The bended end of the aluminum wire is hang on the screw head, and after that the cavity is half fulfilled with two component glue. Such assembly does not contains some substances even in microquantities which would change the surface appearance of the lamp [12-14]. Drying of used glue commonly is pretty short, couple minutes are enough, according to manual instructions of producer. Both parts were sticked together and hold about about 6 minutes, to be sure for obtaining the save connection. At the joined surfaces there were no registered any visible irregularities or deformations, as it was stated in [15]. Views from two side of realised joint at the damaged lamp could be seen at Fig. 5.
