Scientific paper

Zastita Materijala 57 (1)

## Influence of acidic solutions on the strain distribution in glass-polyester composite pipes subjected to internal pressure

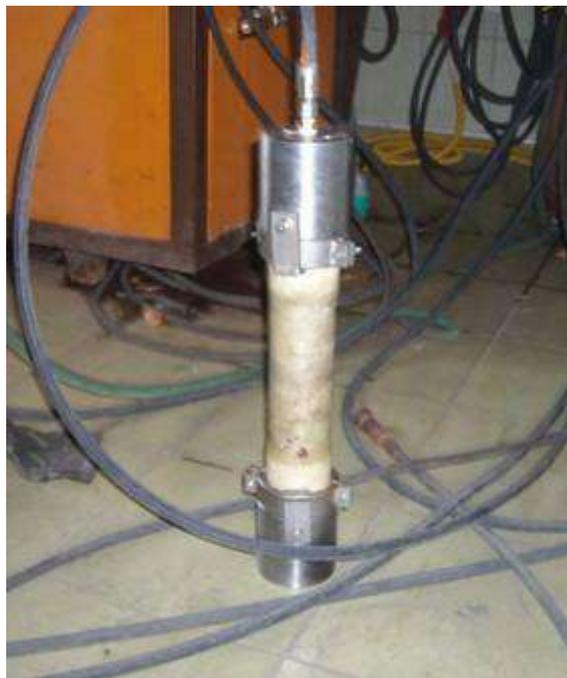
Figure 1 - Metal "cap" fasteners

As mentioned previously, the basic subject of this paper is determination of the strain distribution in glass-polyester pipes subjected to internal pressure. The strain gages were used in order to measure strains in composite pipes subjected to internal pressure. The advantage of this method is that the measured values are turned into electric signal which is easy for further processing. Strain gages (type 6/120 LY11,  $122 \Omega$  with temperature compensation  $K=2.02$ ) were attached to the pipes in rosette configuration, under the following angles:  $0^\circ$ ,  $45^\circ$  and  $90^\circ$  with respect to the pipe axis (Figs. 1 and 2).

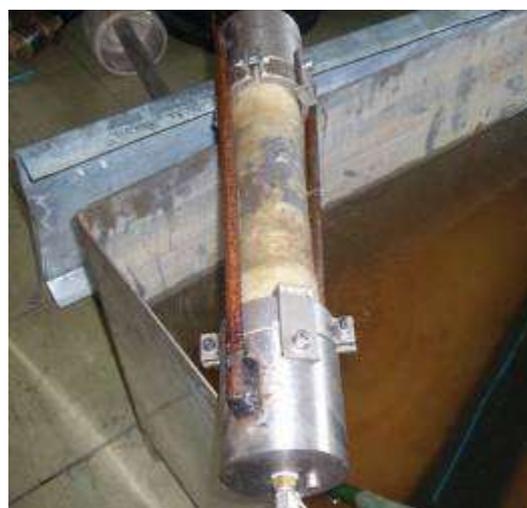
Figure 2 - "Caps" with additional welded bars as reinforcement

difference could be taken into consideration by calculating the forces in screws in the caps and finding the real strain values in axial direction. In some future review and testing, the way the pipes are closed could also be changed, i.e. the closure could be made without the metal bars connecting two opposite caps. However, the configuration tested in this work corresponds to some of the realistic exploitation conditions, where the axial strains are suppressed by some element of the pipeline or equipment (i.e. supporting structure, pressure vessel, pipe support, etc.).

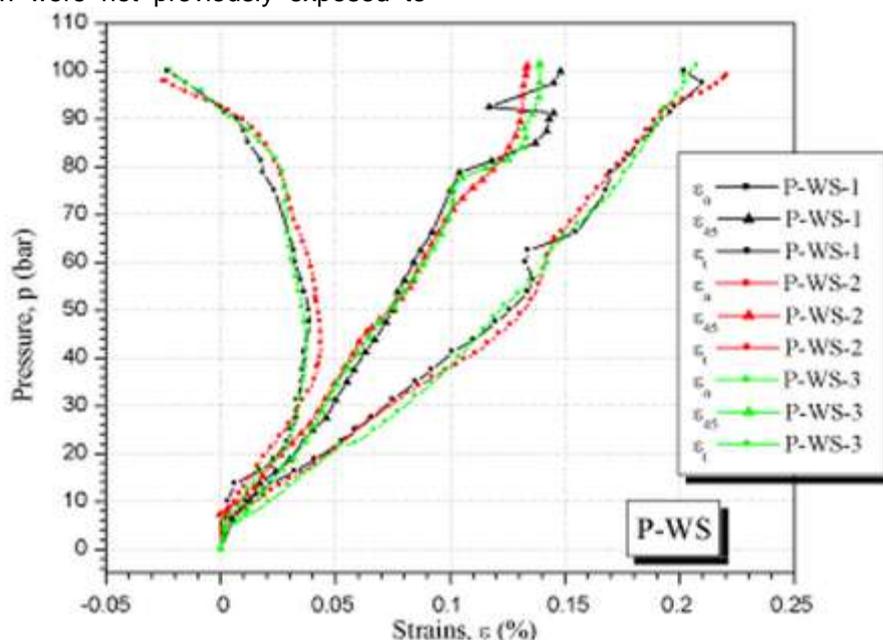
Figure 3 - Pressure-strain diagram for the pipes which were not exposed to acidic solutions

The measurement data are shown in Fig. 3, as dependence of internal pressure on the strains in axial (longitudinal) direction,  $\epsilon_a$ , circumferential (hoop) direction,  $\epsilon_c$ , and direction under the angle of 45°,  $\epsilon_{45}$ . It can be seen that the changes were almost identical for all three pipes (Fig. 3), which confirmed the repeatability of the testing. With some minimal deviations in only a few points, all other strain changes are almost identical.

It is interesting to track the changes of strains in circumferential and longitudinal direction. As expected, when pressure increased to approximately 45 bar the dependence of these two changes was linear (in accordance with the Hook's law,  $\sigma = E \cdot \epsilon$ ). Beyond the pressure value of 45 bar, the strains in circumferential direction continue to increase. Comparison of the strains at the moment of the pipe leakage initiation under the pressure of approximately 100 bar ( $\epsilon_{c, average}=2.19\%$ ) with strains measured by ring test in [1] ( $\epsilon_{c, average}=5.07\%$ ), it can be stated that the appearance of first cracks happened at the moment when strains during internal pressure tests was approximately 40% of strains obtained from the tension test.

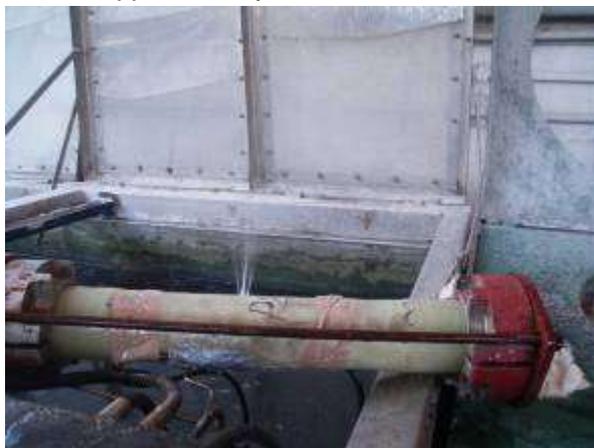
Figure 4 - Start of the pipe leakage

The tests were interrupted when the leakage of the pipes started (Fig. 4); occurrence of the first cracks in pipes was observed at that moment. That happened with all the pipes subjected to internal pressure of approximately 100 bar.

The place of occurrence of the crack was at the distance larger than  $0.1 \cdot l_0$  from the cap for the closure of the end of pipes, which confirmed that the damage was not caused by the attachment of caps to the pipe

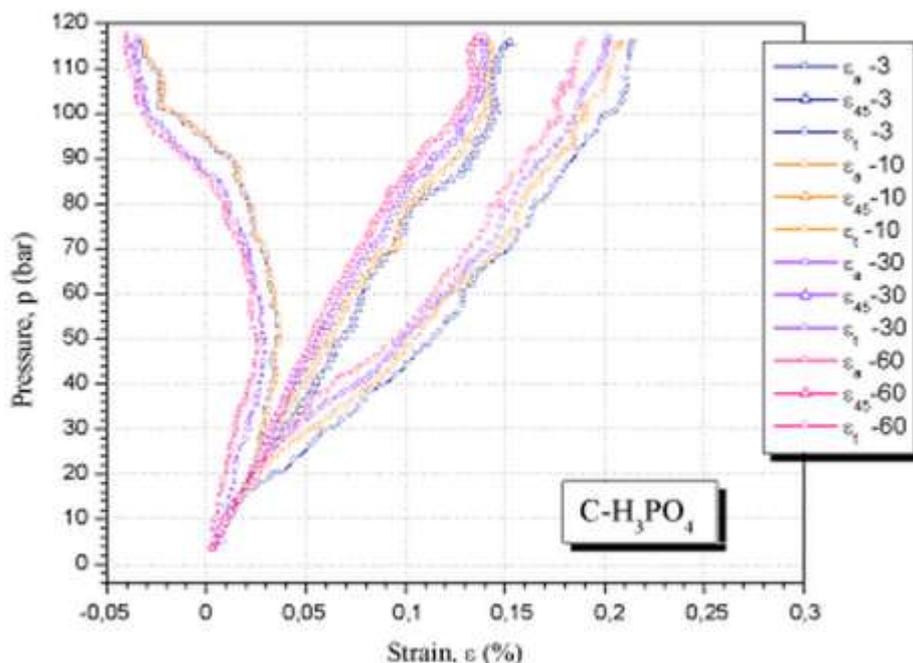
Figure 5 - Pressure-strain diagram for all the specimens exposed to  $H_3PO_4$

In order to get a better insight into difference between the composite pipe properties treated with chemically aggressive substances and those which were not treated, pressure-strain diagrams for the pipes exposed to the phosphoric acid solution and nitric acid solution are shown in Fig. 5 and 6, respectively.

The deviations of the strain values were determined at 40, 60, 80 and 100 bar from the diagrams, for specified number of days during which specimens were exposed to chemically aggressive conditions. The deviations for pipes which were exposed and the virgin ones are given in Tables 5-8.

It can be noticed that all the strains values are decreased after the exposure to acidic solutions. This can be attributed to the change of the rigidity

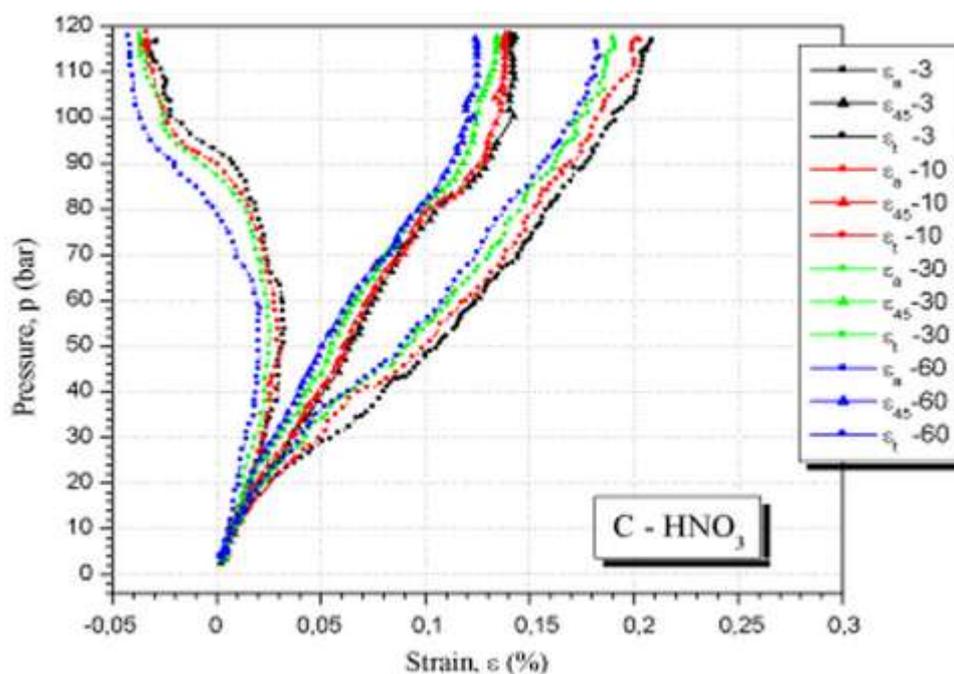
Figure 6 - Pressure-strain diagram for all the specimens exposed to  $HNO_3$ Table 5 - The deviation of strains on  $p=40$  bar

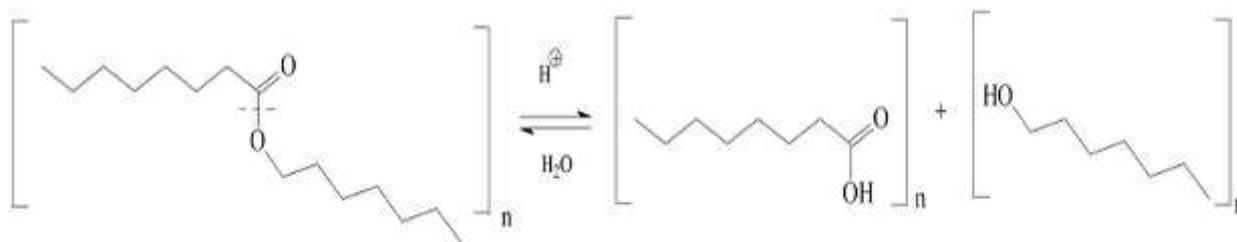
Figure 7 - Acidic polyester hydrolysis

The micromechanical analysis was done by Scanning Electron Microscopy (SEM). It can be concluded that the acidic solutions, regardless of their pH values, affect the polyester resin; this influence can be described as tearing the chains inside the polymer and causing the appearance of micro cracks inside the polymer, which resulted in shortening of the polymer chains and embrittlement. The microcracks are initiated because of the reaction between the acids and the polyester resin as the hydrolysis of the ester bond occurs in acidic medium, fig. 7.

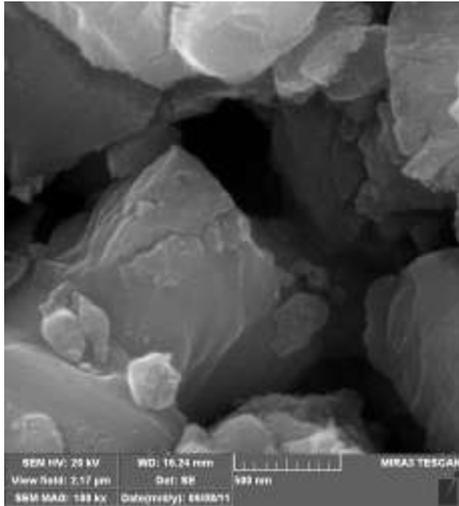
Figure 8 - Decomposition of resin under the influence of acidic solution and the initiation of macro cracks

With the increasing the number of days, the tearing continues and the microcracks merge into a macrocrack, fig. 8.

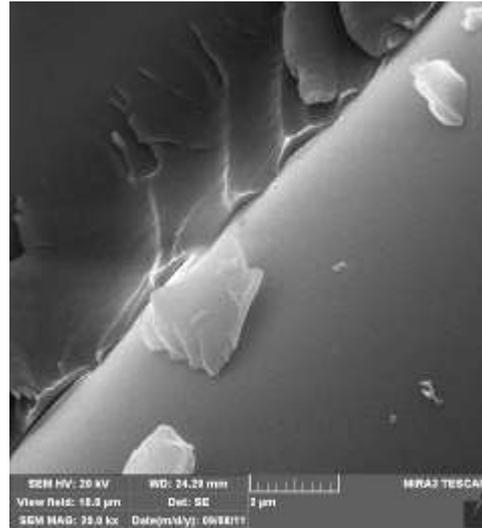
Figure 9c - The remains of the resin in traces after the exposure to acidic solution

matrix (Fig. 9a) were weakened, the components got separated (Fig. 9b) and the composite load carrying capacity decreased until the matrix remained only in traces (Fig. 9c).

The decomposition of resin is in fact the decomposition of matrix, so that the load carrying capacity comes to depend only on fibers. With the matrix loss, the reduction of the wall thickness can be noticed, as well as decrease of the surface of the pipe cross-section.

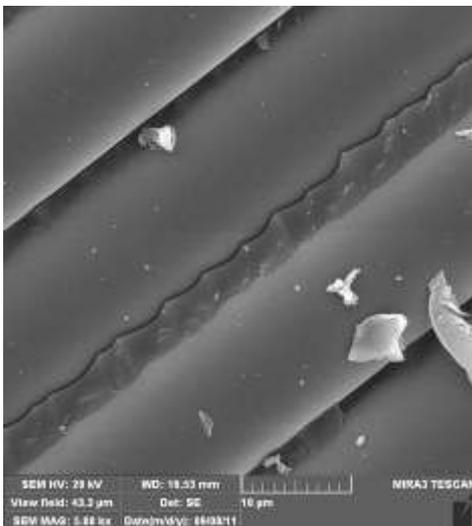
Figure 9a - The bond between fibers and matrix

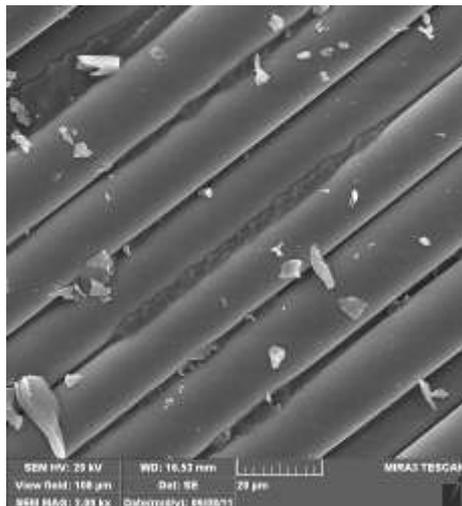
Figure 9b - The beginning of decomposition of the bond between fibers and matrix under the exposure to acidic solution
