Scientific Paper

Zastita Materijala 65 (4)
680 – 689 (2024)

Influence of Different Methods of Surface Treatment on Corrosion Resistance of Low-Alloy Steel

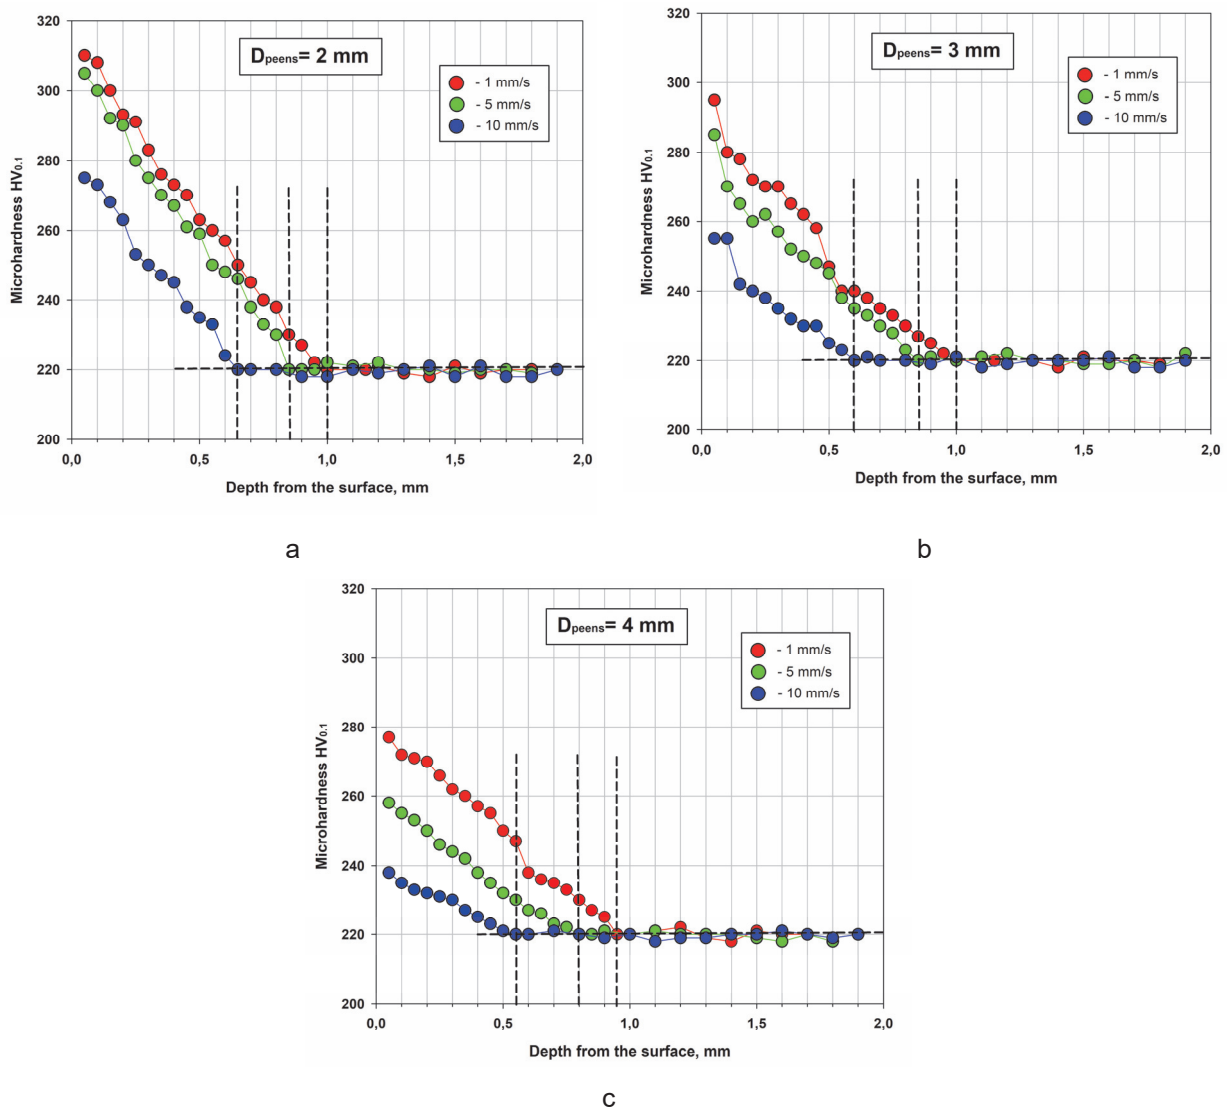
Fig. 1. Dependence of microhardness of near surface metal layer, strengthened by HFMP by using of one-row head with the diameter of cylindrical firing-pins of 2 mm (a), 3 mm (b) and 4 mm (c) from the distance from the bottom of groove to the depth of metal. Speed of implementation of HFMP (Reproduced with permission [15])

Taking into account the above, a hand tool with a removable nozzle was developed for strengthening flat surfaces, in which the impact elements were arranged in several rows. Surface treatment is recommended to be strengthened with circular reciprocating movements at a speed of 35 cm²/min. At the same time, the depth of the strengthened metal layer reached 130-150 microns.

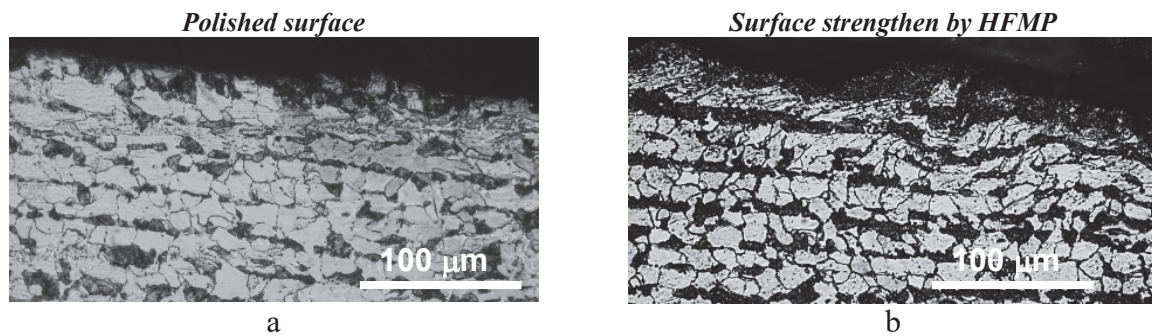
Fig. 2. Microstructure of near surface layers of 15HSND steel with polished surface (P) (a) and surface strengthened by HFMP (b) in the initial state

After choosing the optimal parameters of the HFMP technology, comparative studies of the effect of surface treatment methods on the corrosion resistance of 15HSND steel were carried out. In Fig. 2

show photographs of the microstructure of the near-surface layers of 15HSND steel with a polished surface (Fig. 2, a) (hereinafter P) and a surface processed by HFMP (hereinafter P+ HFMP) technology (Fig. 2, b).

It should be noted that the surface P is not completely flat (**Fig. 2, a**) in some areas of the near-surface layers, a different degree of plastic deformation is observed, which leads to a change in the shape of the grains of ferrite and pearlite, with a shape factor from 1.8 to 4, the depth of penetration of plastic deformation is from 0.03 mm to 0.08 mm. After HFMP (**Fig. 2, b**), the surface of the specimen acquired uneven waviness, in the zone with more intensive deformation - from 0.06 mm to 0.08 mm. A change in the shape of the grains, their extraction with a shape factor from 3 to 5, grinding and the more frequent appearance of second-phase dispersed discharges were noted. In the zone with a lower degree of deformation, with a depth of 0.09 mm

to 0.13 mm, practically no change in the shape of the grains was observed, only the distortion of the ferrite-pearlite striation of the structure was noted.

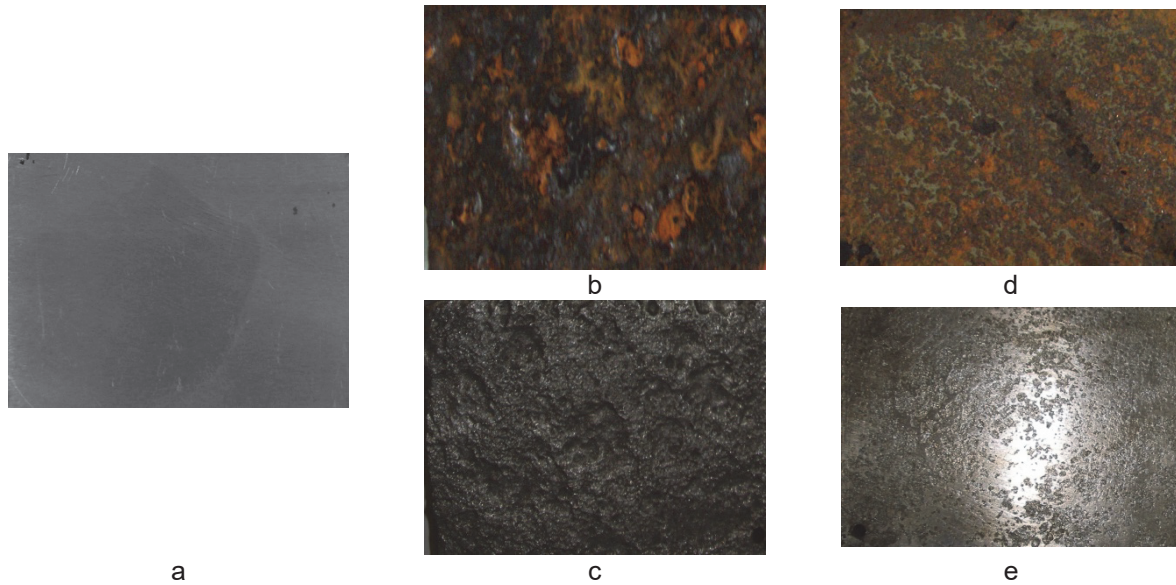
Fig. 3. Appearance of surface of 15HSND steel specimens with polished surface (P) before (a) and after investigations (b, c, d) in the salt fog chamber SF-1 (b, c) and moisture chamber G4 (d, e) during 1200 hours

Photographs of specimens at the initial state (before corrosion tests) with polished surface (**Fig. 3, a**) and surface strengthened by HFMP (**Fig. 4, a**) and after exposure in SF-1 (**Fig. 3, b, c, Fig. 4, b, c**) and G4 (**Fig. 3, d, e, Fig. 4, d, e**) are shown below.

Analyzing the experimental results, it can be noted that after the tests under the influence of neutral salt fog and elevated temperature, all the examined specimens (with surfaces P and P+HFMP) were covered with a thick layer of corrosion products of uneven thickness of brown-black color (**Fig. 3, b, Fig. 4, b**), which were firmly attached to the surface and were very difficult to remove. Areas of the surface without corrosion products with a metallic luster were not observed. After removing the cor-

rosion products, it was noted that the surface is uneven, and corrosion spots are visible over the entire area, with ulcers and pitting inside (**Fig. 3, c, Fig. 4, c**). There are also no areas not affected by local corrosion. Areas with the remains of the reinforcing layer are not visually visible on specimens strengthened by HFMP technology. The corrosion rate after 1200 hours was 2.543 mm/year on the surface of P and 2.096 mm/year on the surface of P+HFMP (**Fig. 5**).

After tests in G4, specimens with the surface P and P+HFMP (**Fig. 3, d, Fig. 4, d**), are covered with an uneven layer of brown corrosion products with black spots. Areas of the surface with almost no corrosion products with a metallic luster are noted, which occupy about 5-7%. After removal of corrosion products, corrosion spots are visible on the surface, smaller in size than after exposure in SF-1, inside some of them pitting has formed, there are areas practically unaffected by local corrosion (**Fig. 3, e, Fig. 4, e**). The corrosion rate was 0.104 mm/year on the P surface and 0.080 mm/year on the P+HFMP surface (**Fig. 5**).

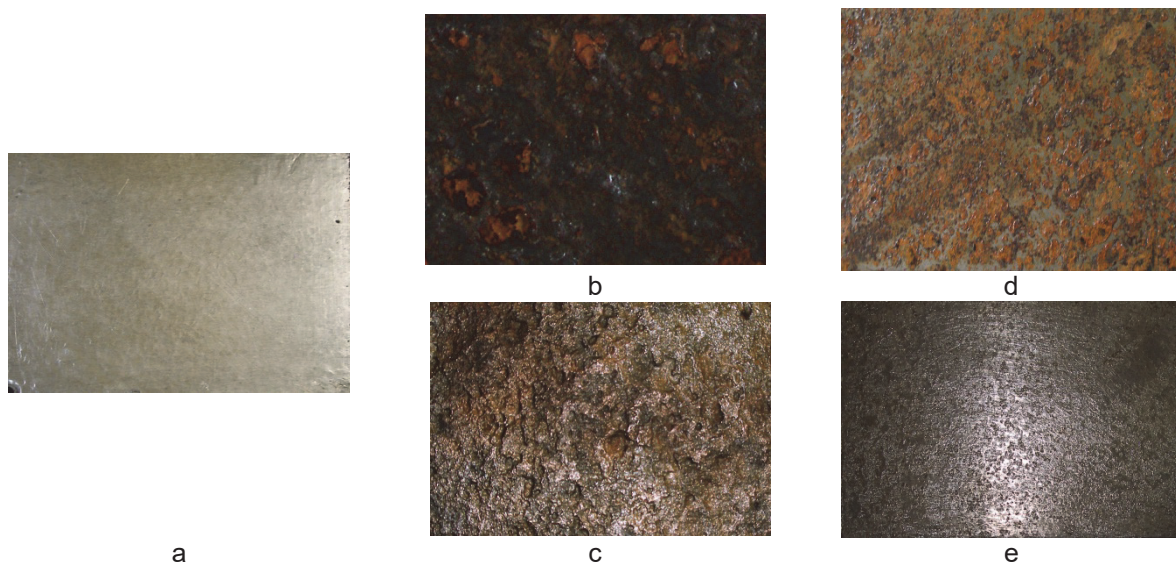
Fig. 4. Appearance of surface of 15HSND steel specimens with surface strengthened by HFMP before (a) and after investigations (b, c, d, e) in the salt fog chamber SF-1 (b, c) and moisture chamber G4 (d, e) during 1200 hours

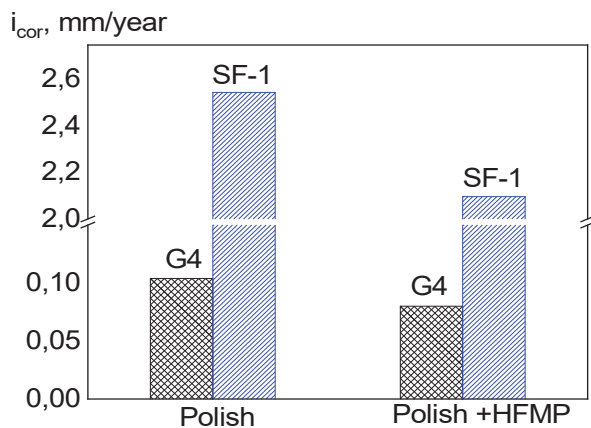
Fig. 5. Comparative diagram of corrosion rate of 15HSND steel with polished surface (P) and surface strengthened by HFMP after accelerated corrosion tests in the salt fog chamber SF-1 and moisture chamber G4 after 1200 hours

HFMP treatment helps to some extent increase the corrosion resistance of the studied steel: the corrosion rate after exposure to neutral salt fog after 1200 hours decreases from 2.543 mm/year on a polished surface to 2.096 mm/year after HFMP treatment, and after exposure to high humidity and temperature – from 0.104 mm/year to 0.080 mm/year, respectively.

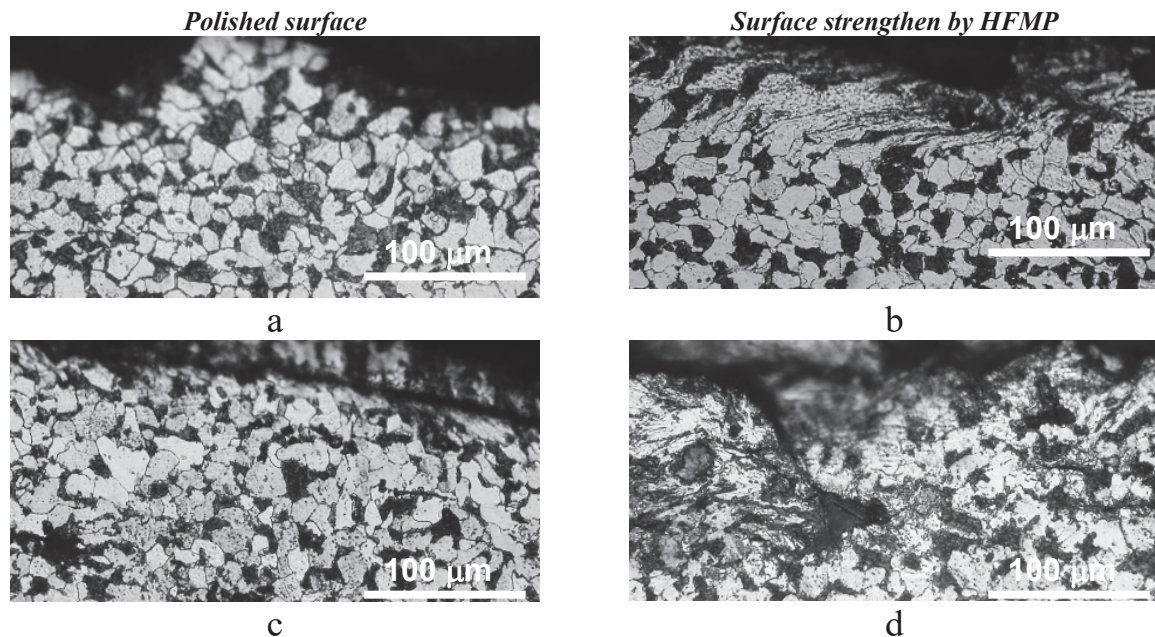
Fig. 6. Microstructure of near surface layers of 15HSND steel with polished surface (P) (a, c) and surface strengthened by HFMP (b, d) after investigations in the salt frog chamber SF-1 (a, b) and moisture chamber G4 (c, d) during 1200 hours.

Some types of surface damage after exposure in SF-1 and G4 are shown in **Fig. 6, b, c**. After exposure in SF-1, continuous uneven corrosion was observed in the surface layers of the specimen with surface P (**Fig. 6, a**), against the background of which deep corrosion lesions were observed in the form of corrosion spots, for example, 2.8 × 0.5 mm, 2.1 × 0.7 mm in size and, less often, corrosion ulcers, for example, in size 1.7 × 1.58 mm. IGC, which started from the boundaries of the ferrite and pearlite grains, and selective corrosion along the pearlite grains were also detected. In addition, in the near-surface layers at a depth of 0.02-0.03 mm, separately located areas with subsurface corrosion from 0.38 mm to 0.413 mm in length were found.

The surface of the specimen P+HFMP was exposed to continuous uneven corrosion (**Fig. 6, b**): mainly, spot corrosion of various sizes, for example, from 0.13×0.03 mm to 1.56×0.26 mm, was detected; in the near-surface layers - by subsurface corrosion of various areas, for example, 0.38×0.012 mm, 0.1×0.007 mm, mainly at a depth of 0.05-0.07 mm, with direct access to the surface of the v; IGC along the boundaries of ferrite grains at a depth of nearly 0.1 mm; selective corrosion of pearlite grains.

In the near-surface layers of the specimen with surface P, continuous uneven corrosion was recorded after the tests (**Fig. 6, c**, and **Table 2**). In addition, relatively shallow (0.03–0.08 mm) corrosion damage is observed, mainly in the form of spots, for example, 0.3×0.05 mm and 0.11×0.017 mm in size; shallow IGC from the boundary of elongated pearlite grains; and more intense selective corrosion along the grains of the pearlite component.

near-surface layers of the specimen with a surface of P+HFMP. The near-surface layers of the specimen were subjected to continuous uneven corrosion (**Fig. 6, d**), relatively shallow (0.026–0.1 mm) spot corrosion was recorded (**Table 2**). In addition, there are areas with subsurface corrosion of different areas, lengths (0.06–0.9 mm), and depths of occurrence (0.01–0.07 mm), both with direct exit and without exit to the metal surface. IGC is not intense and spreads along the boundaries of both ferrite and pearlite grains; selective corrosion of pearlite grains is observed.
