BILJANA BOBIĆ, BORE JEGDIĆ,  
BOJAN GLIGORIJEVIĆ

Scientific paper  
UDC:620.193.4/5

## Analysis of corrosion damage in a boiler made of AISI 304L stainless steel

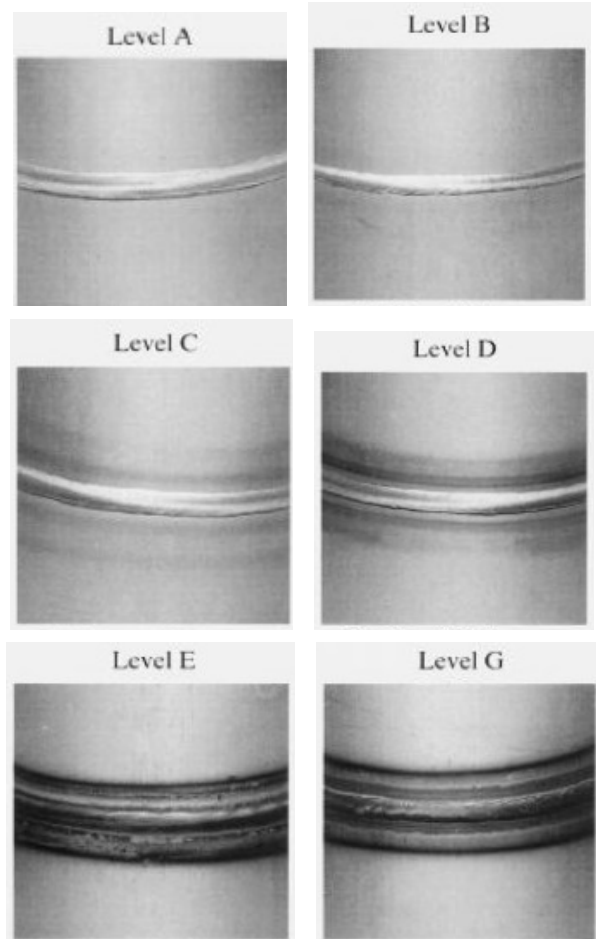
Figure 5 - Reference Colour Chart for different level of the heat tint [15]

Heat tint levels from hardly visible to significant scale formations are illustrated by colour photos and ranged from A to G (Fig. 5). Requirement specified as acceptable heat tint level is usually level B-C. A heat tint of straw yellow (level C) usually indicates the limit between unaffected properties of austenitic stainless steels and a more or less pronounced loss of resistance toward pitting and crevice corrosion.

Heat tint in the root of circumferential welded joint on the inner side of boiler was formed because the welding was performed without the shielding gas. Heat tint on the outer side of boiler was not formed because the shielding gas was used during welding. The longitudinal welded joint was also formed in the shielding gas (root and the face side of the weld) and the heat tint was not formed.

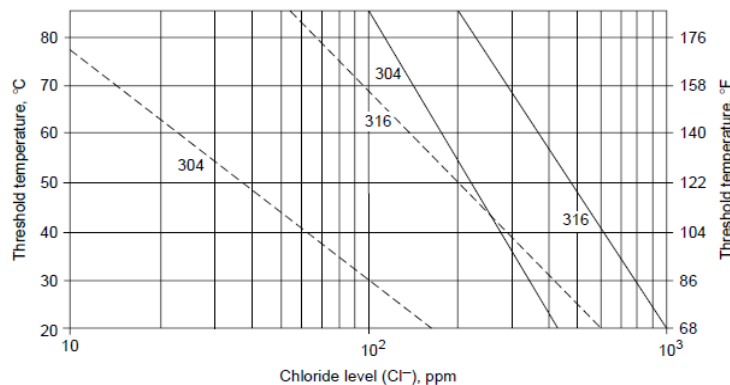
Figure 6 - Risk of pitting (solid line) and crevice corrosion (dashed line) of standard grades of stainless steels in waters with varying chloride levels [16]

Stainless steel AISI 304L is not prone to pitting and crevice corrosion if the chloride content in water and water temperature do not exceed the critical levels (Fig. 6).

Replacement of the stainless steel AISI 304L with the stainless steel AISI 316/316L which contains 2-3 % Mo, because this stainless steel is far more resistant to pitting and crevice corrosion.
